## Water Environment Improvements Project Evidence Form

Milkwellburn Wood

Company/ Organisation	Named Lead	Position	
Durham Wildlife Trust	Mark Dinning	Head of Conservation

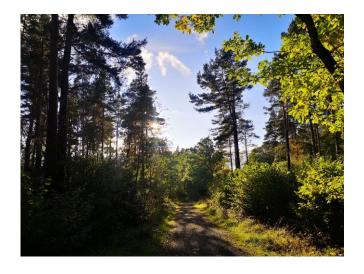
- Footpath surface improvements
- Design and production of 2 new interpretation panels (due to be installed summer 2024)
- Construction of 10 leaky dams using volunteers and local materials
- Construction of an overflow by-pass channel to prevent flooding in high rainfall

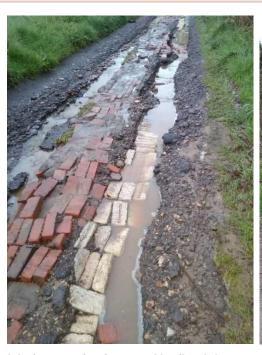
Entrance track before repairs, impacted by flood damage, and improved surface during volunteer repairs

- 2. Repairs to the entrance track and the creation of an overflow by-pass channel to prevent future flooding has made the site accessible to all, which should still be possible during high rainfall events.

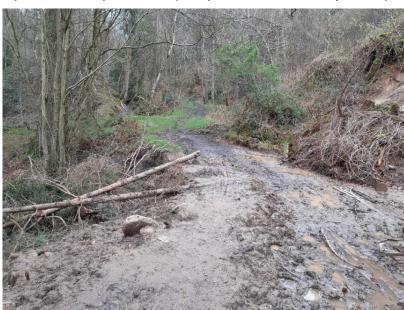
Before and after erosion repairs by a contractor and culvert repairs by volunteers (surfacing to be completed soon)

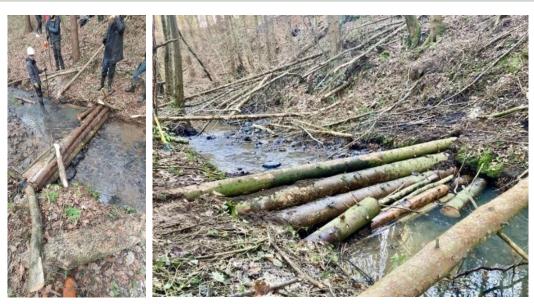
Woody dam construction

1. In total 13 run off attenuation features (woody dams) have been installed by volunteers using natural material on site, creating microhabitats for invertebrates and other wildlife. A culvert overflow bypass channel was also created by contractors in 2023. Willow weaving was also used across the site as a natural solution to protect banks from erosion. The success of the woody dams means further features will be incorporated into future site management activities.
